Archaeological Recording

The Bungalow, Culrain Sutherland

Report No.	HAS060709
Client	S Bayliss
Planning Ref	05/00324/FULSU
Date	28 July 2006
Author	John Wood

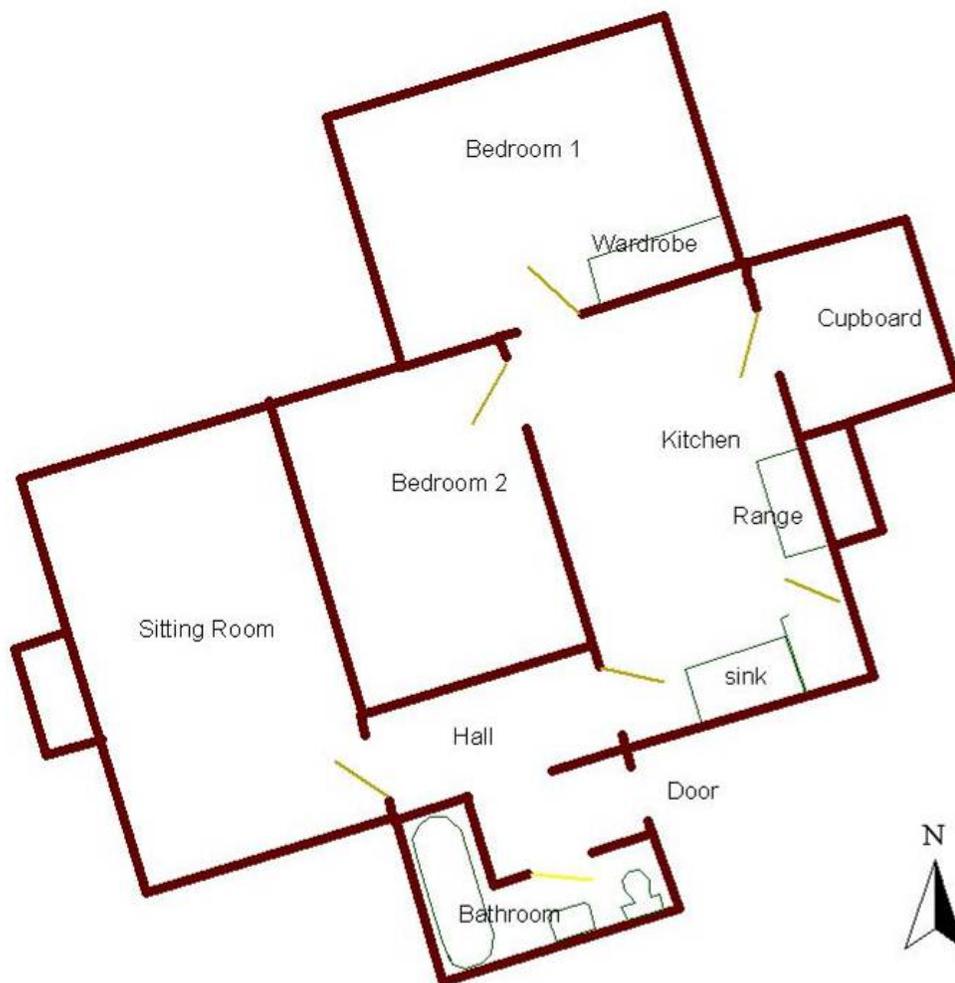
Figure 5 The bungalow – sketch plan (as existing). Not to scale.

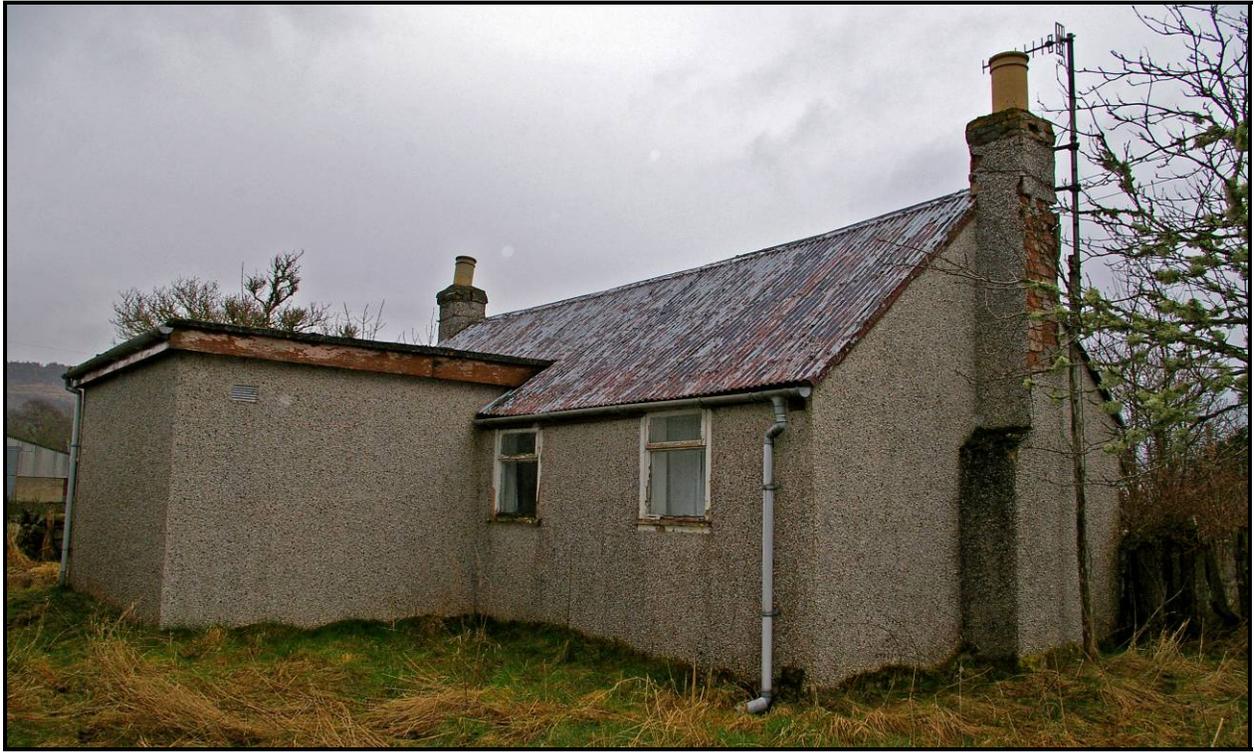
Figure 6 The Bungalow from the NW showing rear extension

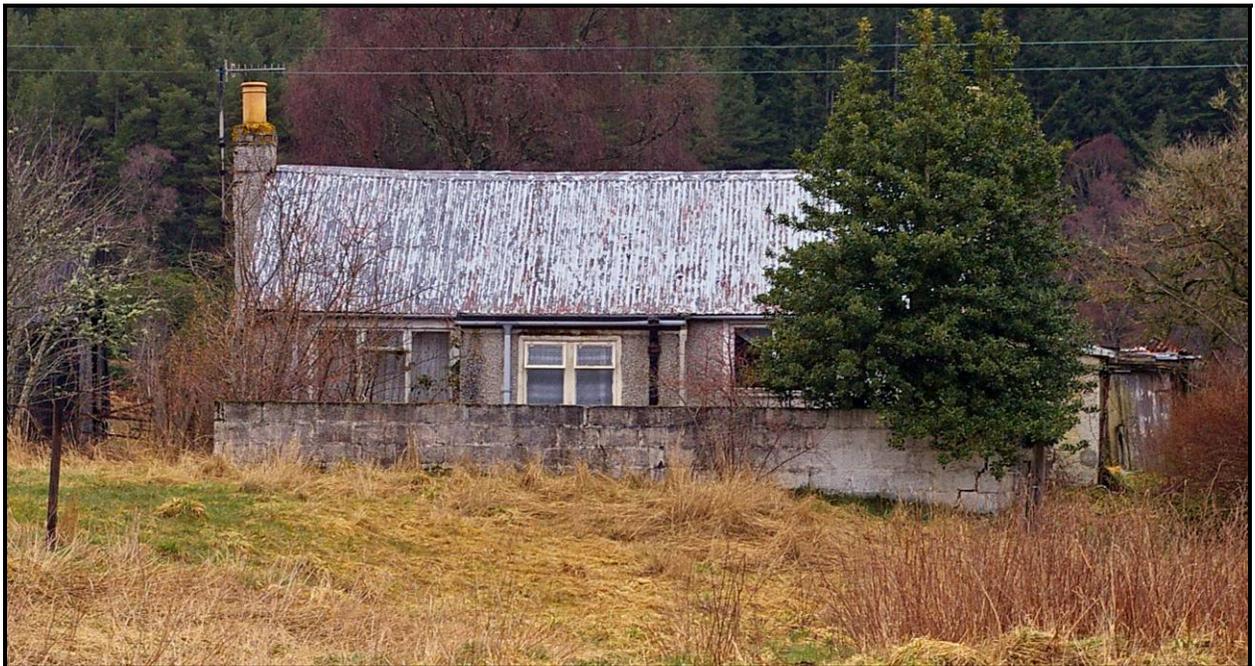
Figure 7 The Bungalow from the South, showing front extension

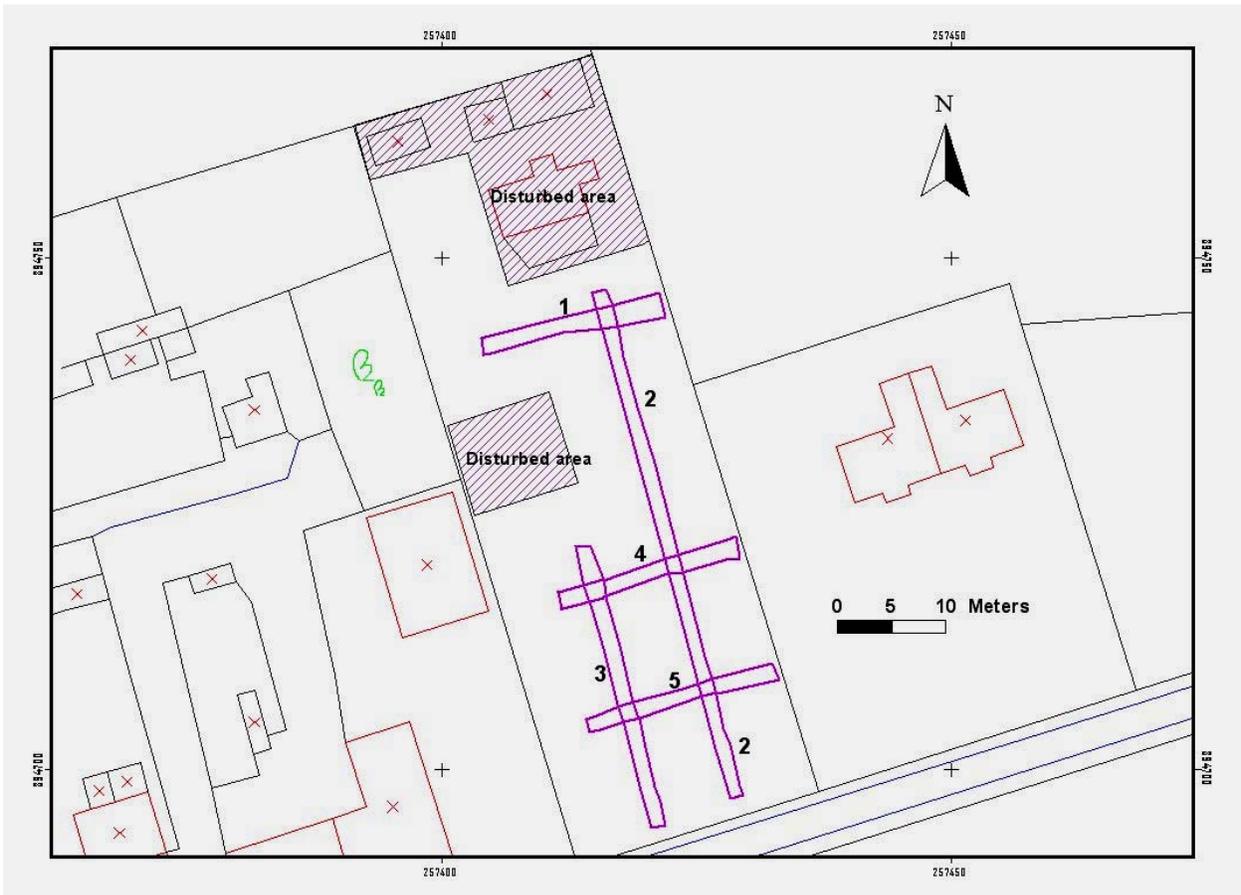
Figure 14 Trenches as excavated
Note Trench numbers.

All trenches were cut with a 1.5m wide ditching bucket on a back-acting mechanical excavator, under the supervision of an archaeologist. Where necessary hand cleaning by hoe and / or trowel was then undertaken to check any possible features. Two parts of the site could not be excavated – the ground occupied by the existing house and sheds, and the cess pit / soakaway. These are marked as *Disturbed Areas* on Figure 14.

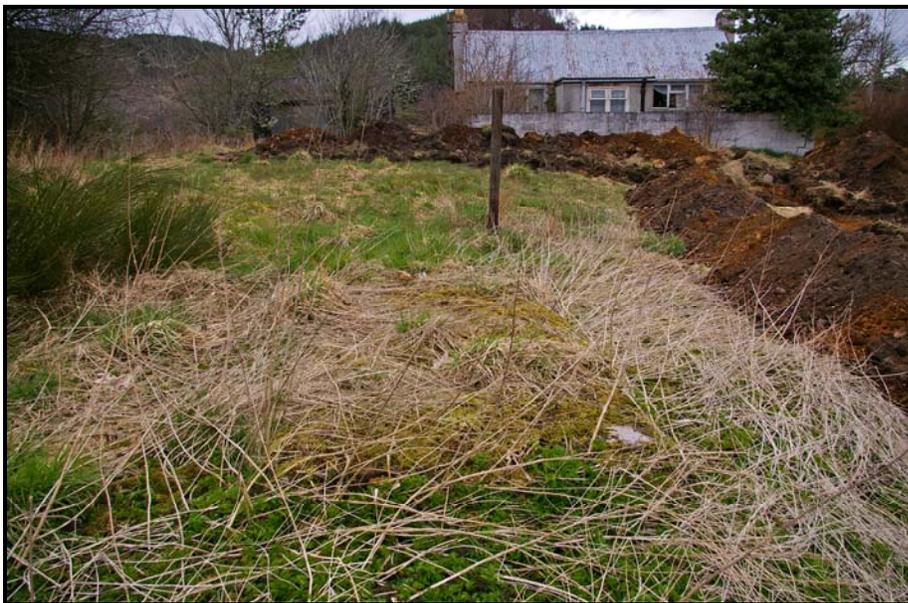
Figure 15 Soakaway

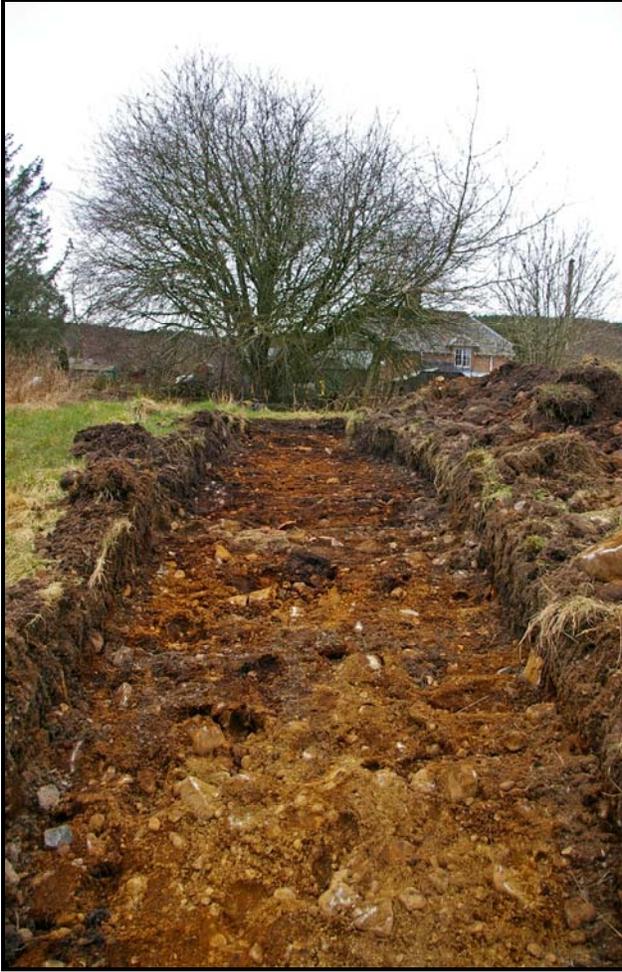
This was an additional trench cut to check the northern area of the site. It was approximately 18.2m long, running roughly east-west across the site. The depth varied but averaged about 500mm. This trench encountered the drain from the bungalow to the soakaway at approximate grid ref 257409 894743. See Figs 16 and 18

Figure 16 Trench 1, looking west

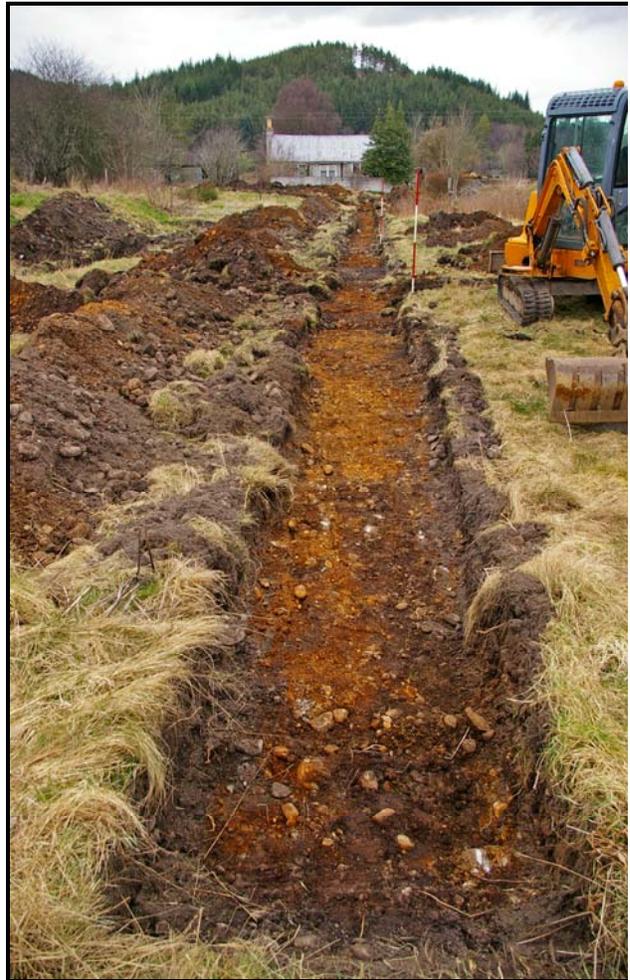
This was approximately 51.2m long, running roughly north-south across the site, parallel to Trench 1. The depth varied but averaged about 500mm. See Fig 17. A grown-over section of metalling for the driveway was encountered in this trench at approximate grid ref 257422 894712

Figure 17 Trench 2 looking north

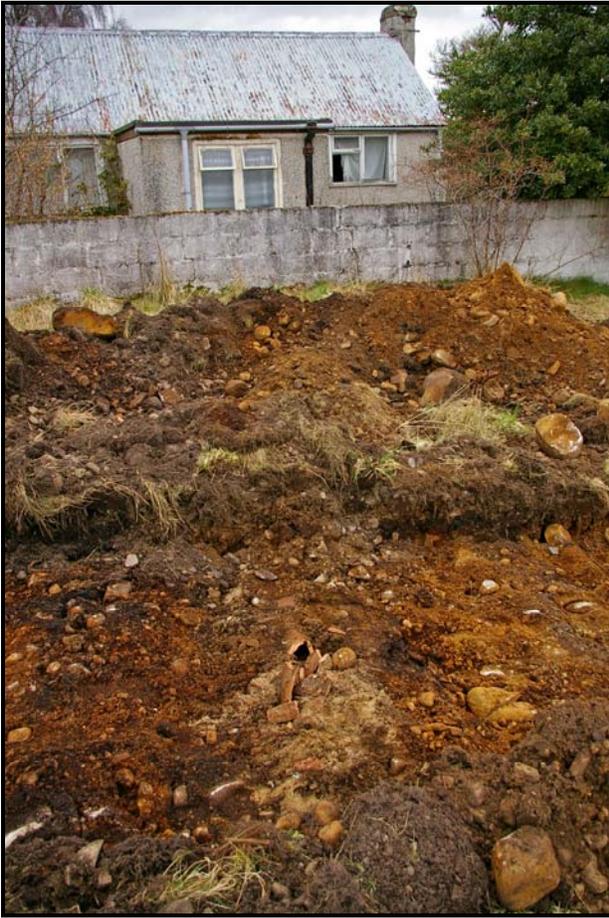
Figure 18 Drain to soakaway, encountered in Trench
1

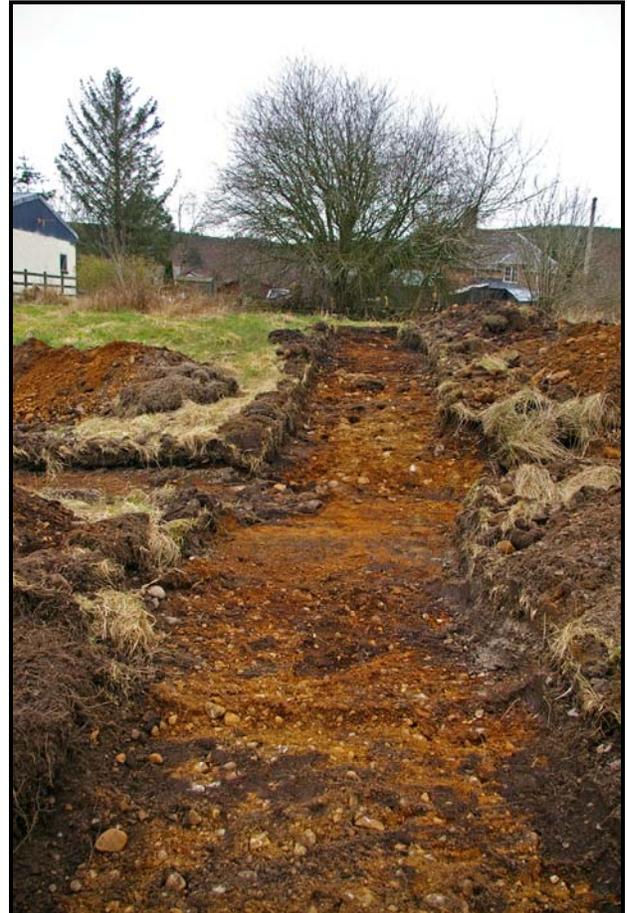
This was approximately 28.5m long, running roughly north-south across the site. The depth varied but averaged about 500mm. See Fig 19.

Figure 19 Trench 3, looking north

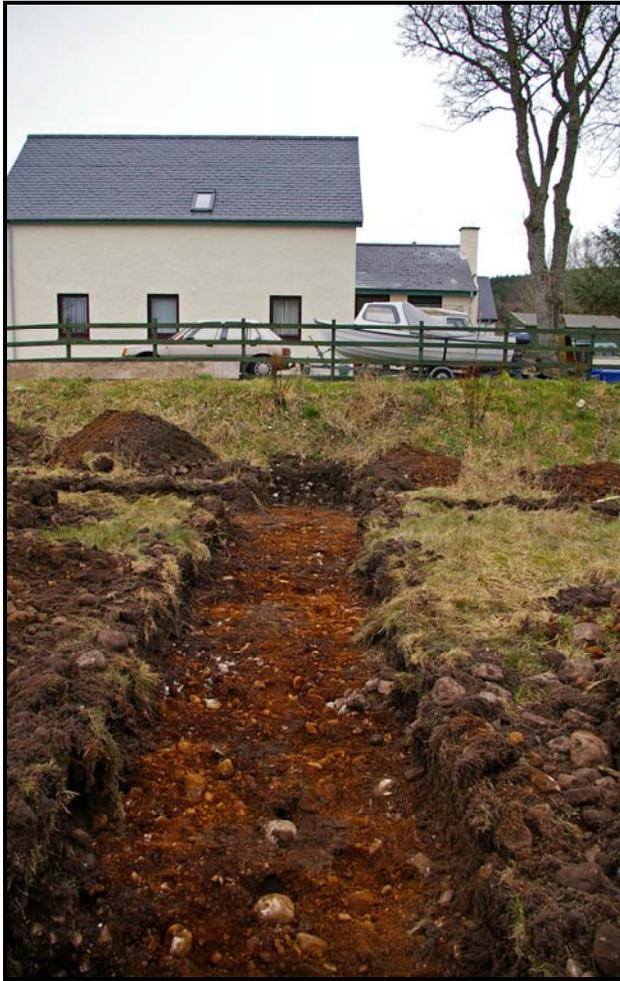
This was approximately 18.4m long, running roughly east-west across the site. The depth varied but averaged about 500mm. The ground rose sharply at the western end of this trench where it had been made up to form a platform for the adjoining property. See Fig 20.

Figure 20 Trench 4, looking west

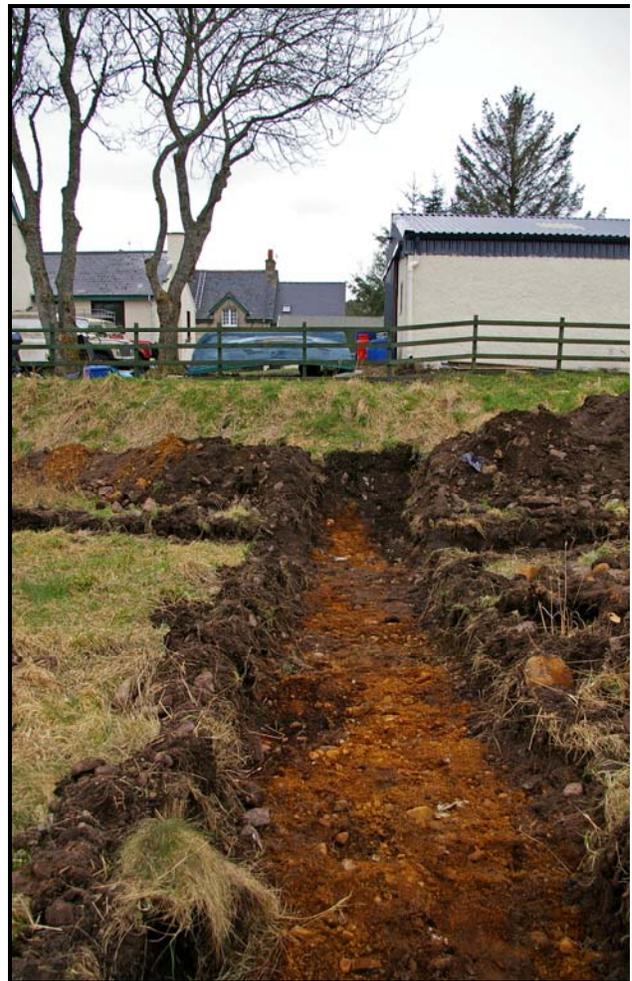
This was approximately 19m long, running roughly east-west across the site. The depth varied but averaged about 500mm. The ground rose sharply at the western end of this trench where it had been made up to form a platform for the adjoining property. See Fig 21.

Figure 21 Trench 5, looking west

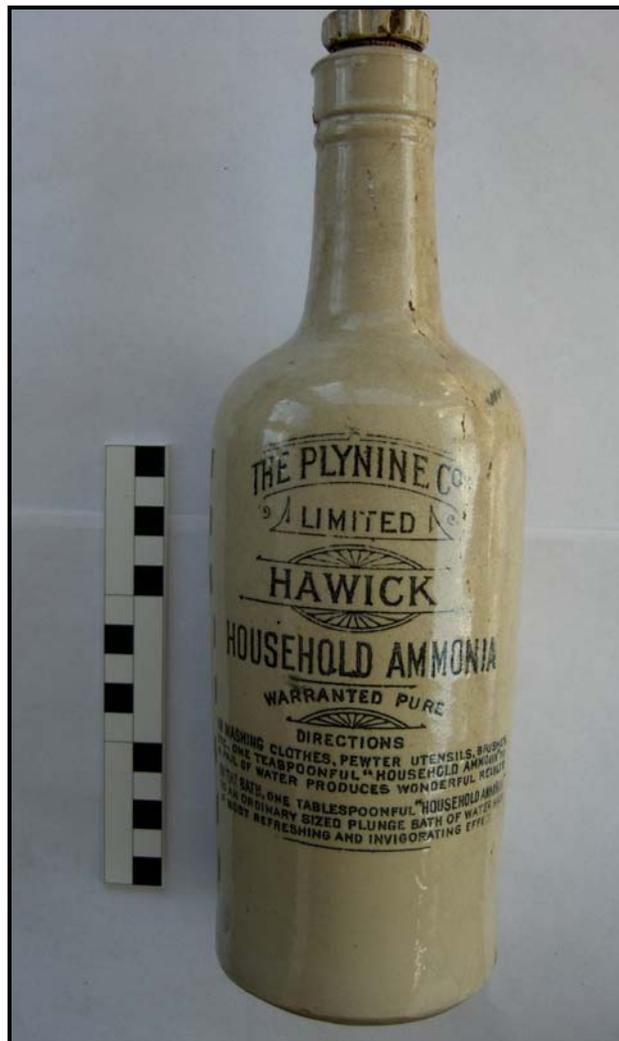
All finds were apparently of 20th century date. The area had apparently been much disturbed by the creation of a soakaway and the dumping of materials at various dates, but there was no apparent residual material from earlier occupation.

Figure 22 Finds were all apparently 20th c. in date
